# **Colliers Property Inspections** **Property Inspection Report**

5401 Test Drive Ave, Las Vegas, NV 89130  
Inspection prepared for: Justin Collier  
Date of Inspection: 2/19/2023 Time: 10:00 AM  
Age of Home: 22 Years Size: 2275  
Weather: Sunny and Clear

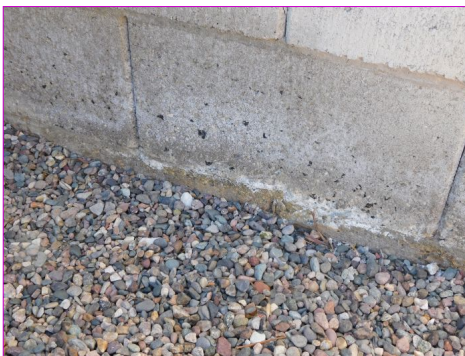
GROUNDS Boundary Walls

- Boundary walls were made of concrete masonry units (CMU) commonly called concrete block.
- Boundary walls exhibited moderate damage or deterioration. The inspector recommends repair by a qualified contractor.

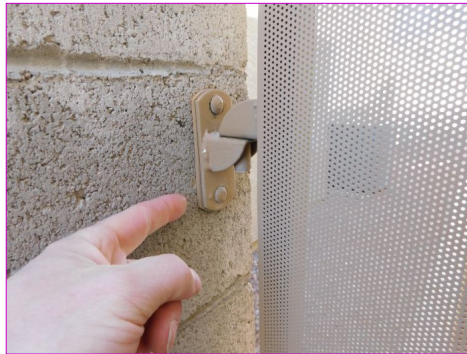
*GROUND'S Gates*

- The gates were made of metal.
- The hinges are slightly loose on both the top and bottom where bolted to the concrete masonry unit wall. Recommend these be repaired by a licensed contractor.

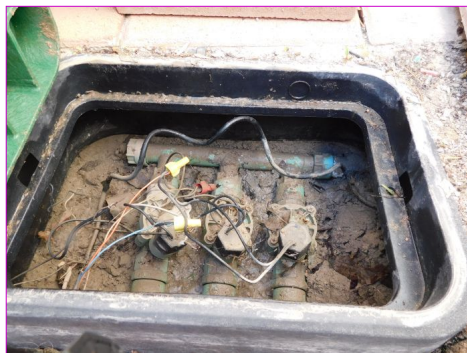
*GROUND'S Landscape Irrigation*

- Several zone valves appeared to be leaking. The Inspector recommends repair by a qualified contractor.

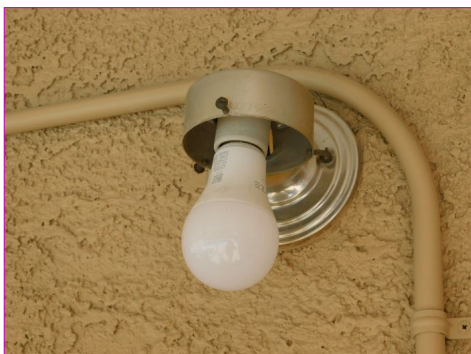
EXTERIOR ELECTRICAL Exterior Lighting

- There isn't a recommended height for ceiling fans in the National Electrical Code or International Residential Code, however most manufacturers recommend a height of no less than 7 feet from the ground. This fan is 81 inches from the ground and is 3 inches below most manufacturer recommendations. Recommend raising the fan if possible. However, a ceiling fan needs a minimum of 8 inches of clearance from the ceiling to produce it's full rated volume of air.
- Cover missing on light fixture. Recommend repair.

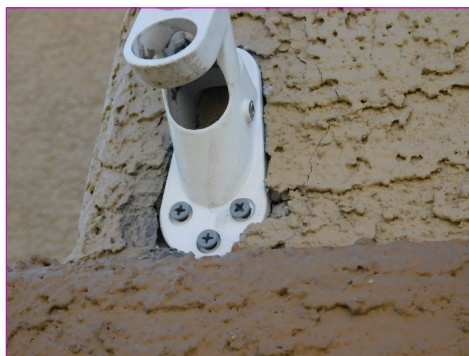
EXTERIOR WALLS Stucco Condition

- The Inspector observed few deficiencies in the condition of stucco covering exterior walls of the home. Notable exceptions will be listed in this report.
- Stucco covering exterior walls of the home had minor damage visible at the time of the inspection.
- Stucco covering exterior walls of the home had moderate visible damage that should be repaired to prevent possible moisture intrusion or additional damage from exposure to freezing moisture.

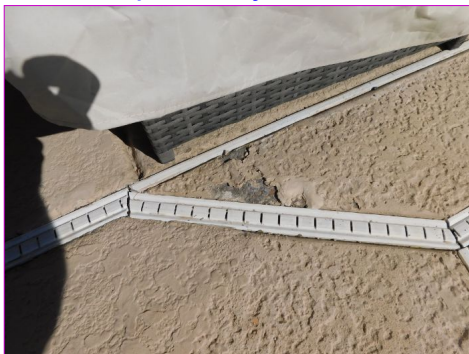
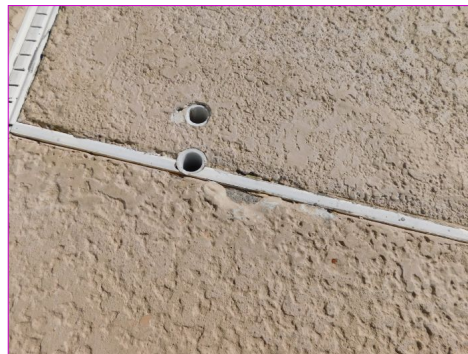
*PATIO Patio Condition*

- Cool Deck material around the swimming pool is starting to chip away in spots. This is technically a cosmetic issue, but it is recommended to address this issue and have it repaired by a licensed contractor to avoid further deterioration.

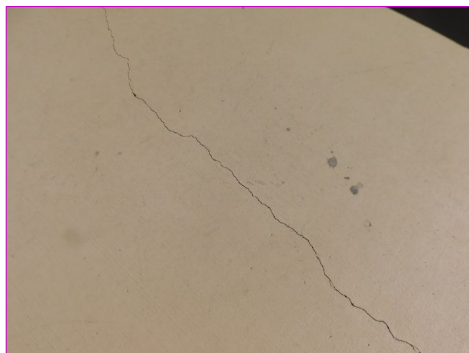
*PATIO Patio Slab Condition*

- The patio surface had moderate cracking visible at the time of the inspection. Cracks wider than 1/4-inch should be filled with an appropriate material to help prevent continued deterioration. All work should be performed by a qualified contractor.

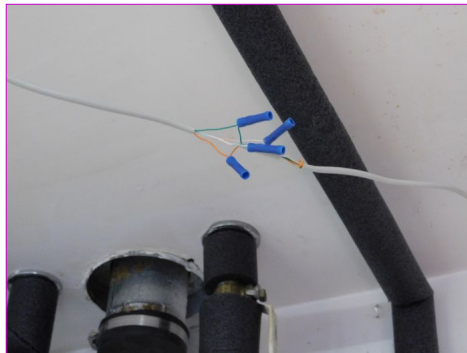
GARAGE Garage General Condition

- At the time of the inspection, the Inspector observed few deficiencies in the condition of the garage. Notable exceptions will be listed in this report.
- Low voltage wiring splices together noted in garage. These wires appear to be for a security camera system. The security camera system is out of scope for this inspection, however these splices wire are being noted for your information.

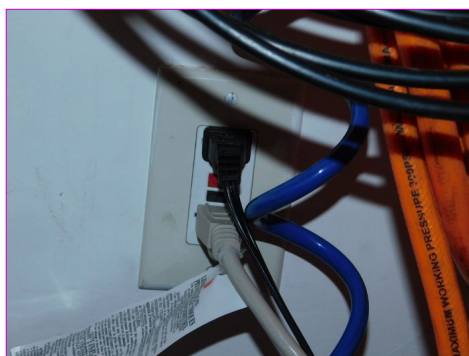
*GARAGE Garage Electrical Defects*

- Observations:** The GFCI could not be tested because of occupants belongings plugged into the receptacle. The freezer was plugged into the GFCI receptacle and because of this I made the decision not to test this receptacle in case it would not reset.

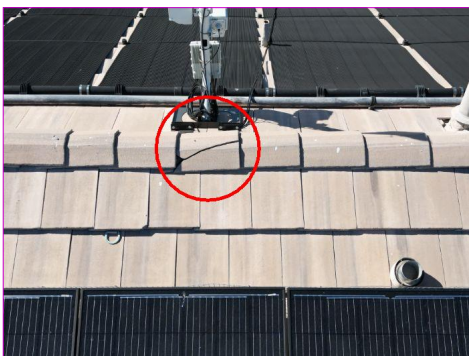
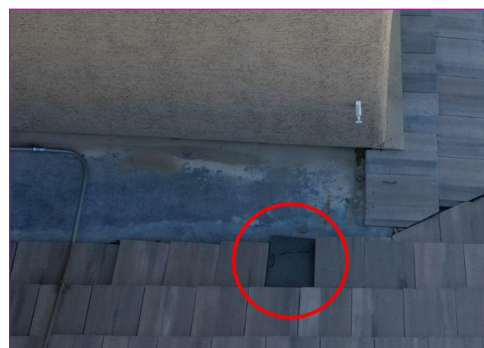
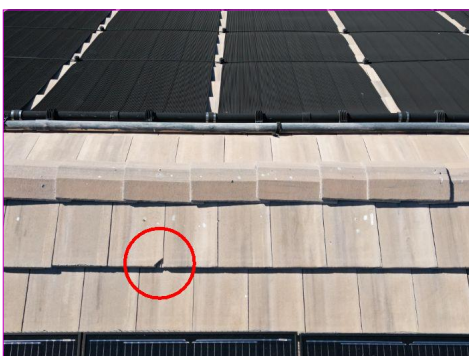
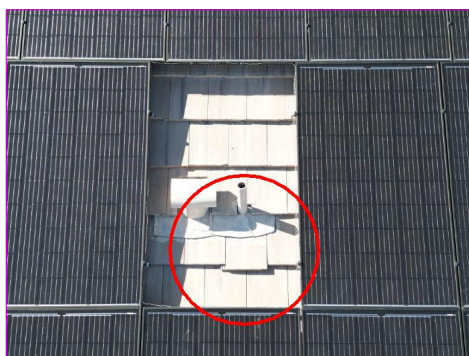
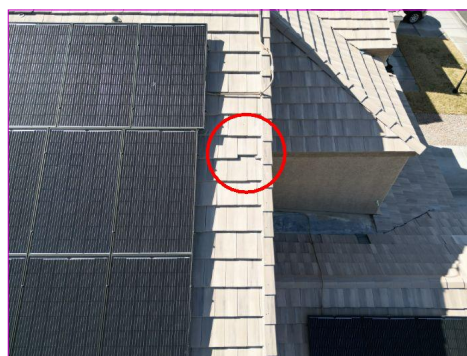
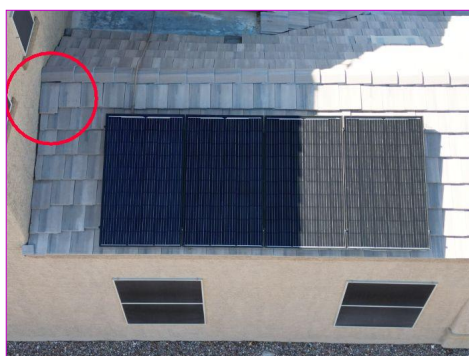
CONCRETE TILE ROOFS Tile  
Roof Condition

- The roof had cracked and/or broken concrete roof tiles that should be replaced to help prevent damage from moisture intrusion to the home materials, the roof structure and to prevent development of microbial growth such as mold. The Inspector recommends that before the expiration of your Inspection Objection Deadline you consult with a qualified contractor to discuss options and costs for repairs.

- Roof tiles that had been inadequately fastened have been displaced by wind. The tiles should be replaced by a qualified roofing contractor in a manner that will hold them securely in place.

- Concrete tiles in some portions of the roof were slipping downhill. These tiles had been cut to length, and fastener holes were discarded with tile waste. The Inspector recommends that any such tiles be replaced by a qualified roofing contractor using an appropriate adhesive.

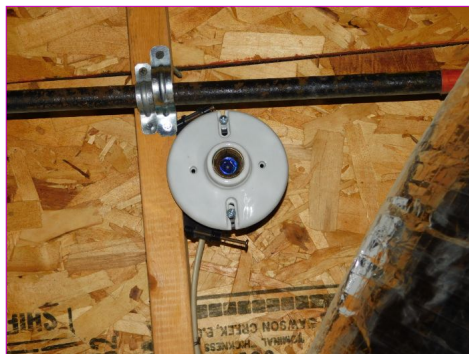
*ATTIC Attic Electrical*

- The Inspector observed few deficiencies in the condition of the electrical components in the attic at the time of the inspection. Notable exceptions will be listed in this report.
- The attic space light was not working. Upon further investigation it is noted that the bulb was broken out of the socket. I recommend this be repaired by a licensed electrician.

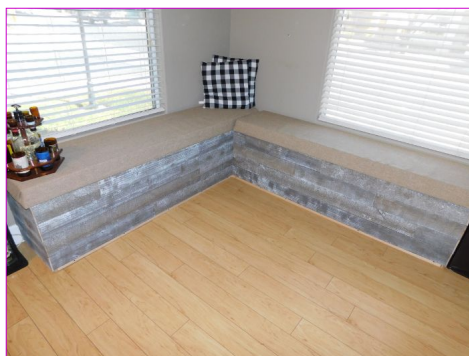
*GENERAL INTERIOR General Condition*

- A bench has been built and installed in the corner of the downstairs family/living room. It is recommended this bench be evaluated by a licensed contractor to ensure it is safe.
- Inspection of the interior typically includes examination of the following components...

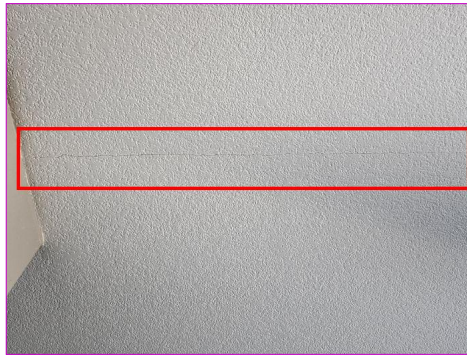
GENERAL INTERIOR Ceiling

- At the time of the inspection, the Inspector observed few deficiencies in the condition of ceilings in the home. Notable exceptions will be listed in the appropriate place in this report.
- **Settlement Crack in ceiling. This is a common settlement crack, but I recommend monitoring this crack and if becomes wider or moves in another direction then a licensed contractor should be contacted for evaluation.**

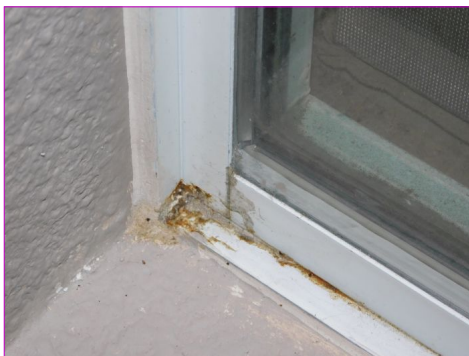
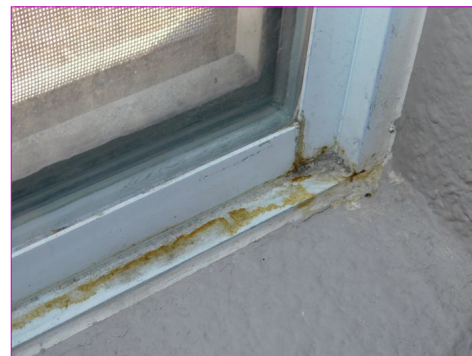
WINDOWS Window Sill/Jamb Condition

- A window sill in the downstairs family room exhibited minor damage that appeared to be from moisture intrusion. Sealant around the window exterior should be maintained to avoid continuing damage.

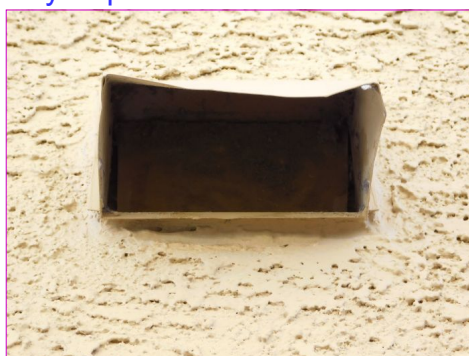
*LAUNDRY ROOM Dryer Venting*

- At the time of the inspection, the Inspector observed no deficiencies in the condition of the dryer exhaust duct.
  - A dryer exhaust duct connection was installed in the laundry room. Although the Inspector operated the dryer briefly, the dryer duct was examined visually only. A visual examination will not detect the presence of lint accumulated inside the vent, which is a potential fire hazard.
- The Inspector recommends that you have the dryer duct cleaned at the time of purchase and annually in the future to help ensure that safe conditions exist. Lint accumulation can occur even in approved, properly installed exhaust duct. All work should be performed by a qualified contractor.

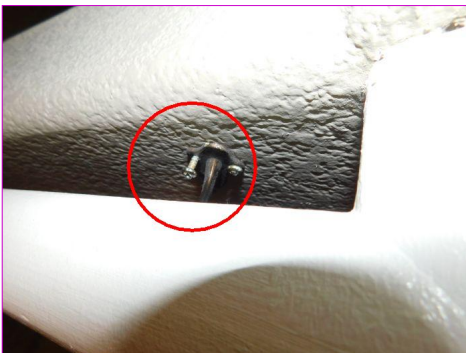
STAIRWAY to 2nd FLOOR Handrail Assembly

• The handrail at this staircase did not appear to have attachment hardware that adequately secured the handrail to the wall. Inspector recommends that attachment hardware be installed to make the handrail attachment to the wall secure. Physical testing for compliance with any building standards or building codes lies beyond the scope of the General Home Inspection. The Inspector recommends correction by a qualified contractor.

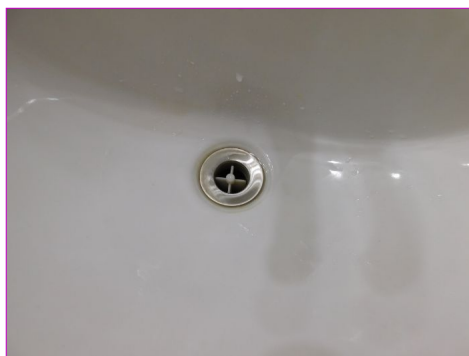
MASTER BATHROOM Double Sink

- At the time of the inspection, the Inspector observed no deficiencies in the condition of both bathroom sinks.
- One sink in this bathroom had an inoperable stopper.

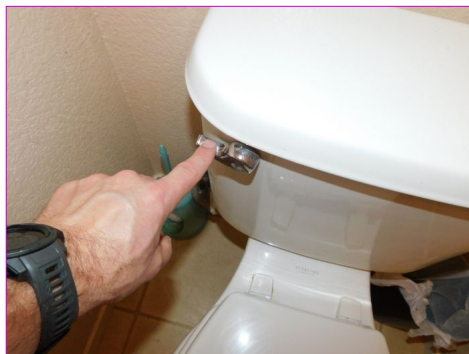
MASTER BATHROOM Toilet Type/Operation

- This bathroom did not have a low-flow toilet installed. New construction is limited to toilets which use a maximum of 1.6 gallons (6 liters) per flush in order to help conserve water. Consider adding a displacement bag to the water tank to help conserve water. A displacement bag is a plastic bag filled with water. A sandwich bag will work.
- The toilet in this bathroom was slow to flush. The toilet did not flush fully with one press of the handle. It only performed a half flush and I had to hold the handle down to get a full flush. The Inspector recommends repair by a qualified plumbing contractor.

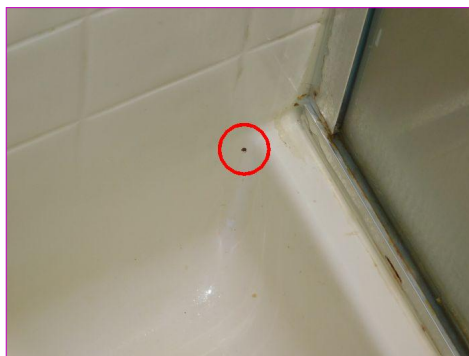
MASTER BATHROOM Shower Enclosure

- Small hole in the corner of the shower base that could allow moisture intrusion. Recommend repair by a licensed contractor.

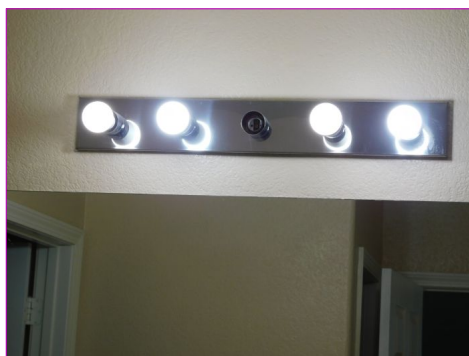
MASTER BATHROOM Light Fixtures

- Master bath vanity missing light bulb.

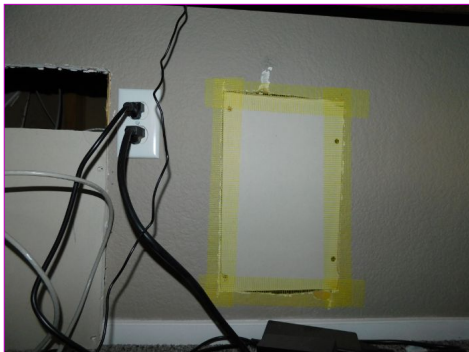
MASTER BEDROOM Walls

- The walls in this bedroom exhibited moderate damage. Before the expiration of your Inspection Objection Deadline you may wish to consult with a qualified contractor to discuss options and costs for repair.

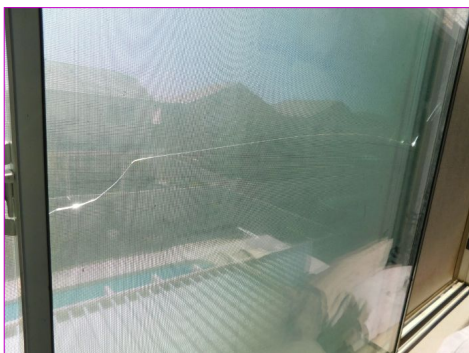
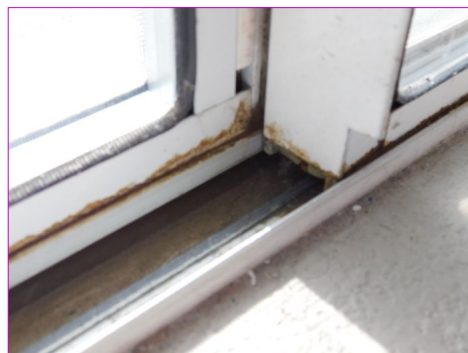
MASTER BEDROOM Window Condition

- A window sill in this bedroom had suffered moderate moisture damage. The window exterior should be sealed with an appropriate sealant that should be maintained on a regular basis. The Inspector recommends service by a qualified contractor.
- Window pane cracked. Recommend repair or replacement by a licensed contractor.

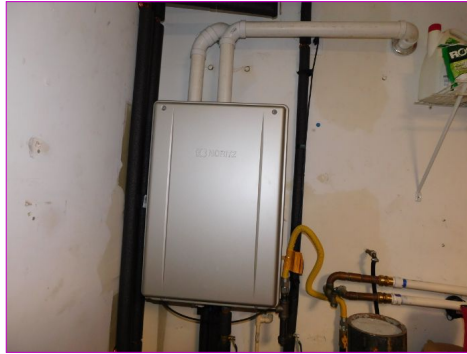
WATER HEATER Water Heater Type

Due to calcium build-up on components, tankless water heaters may require service annually. Failure to service the water heater in a timely manner typically results in a reduced hot water flow rate. The Inspector recommends inspection by a qualified contractor.

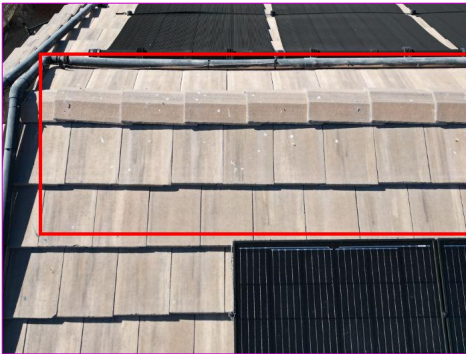
PESTS Birds

• Pigeon feces noted on the roof tiles. Pigeon feces is acidic and over time can damage your roof tiles. Pigeon feces is also a potential health concern. Breathing dust or water droplets containing contaminated bird droppings can lead to several diseases, including a flu-like illness called psittacosis. Salmonella - a bacterial infection that can cause diarrhea, may also be present in some bird droppings. If you are cleaning up or come into contact with droppings, you should take precautions. Wash your hands and clean any exposed skin before eating, drinking or putting your hands near your mouth. It is recommended you hire a licensed contractor to remove and clean the roof tiles as needed to remove the bird droppings.

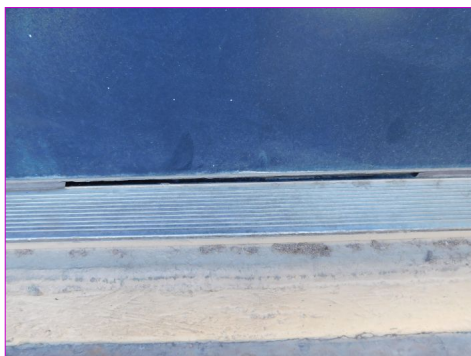
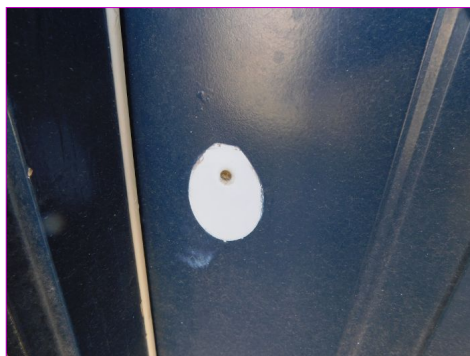
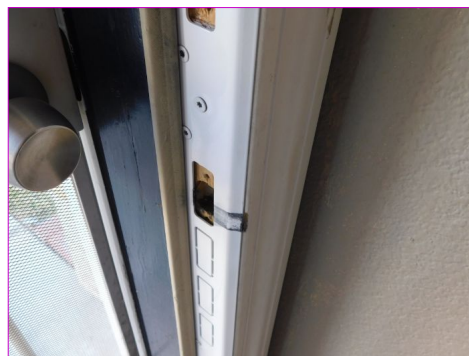
DOORS Exterior Door Condition DOORS Exterior Door Condition DOORS Exterior Door Condition

- The Inspector observed few deficiencies in the condition of exterior doors. Notable exceptions will be listed in this report.
- There is a small hole in the entry door from a previous door handle that was a different style. This hole has been filled with silicone. Monitor and repair/replace as needed.
- Weather-stripping at an exterior door in the downstairs family room was damaged or deteriorated. The Inspector recommends replacement/installation of effective weather-stripping components as necessary by a qualified contractor.

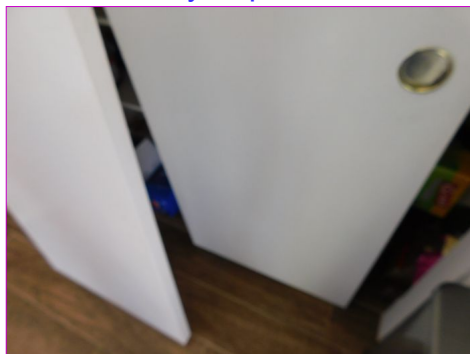
DOORS Closet Doors

- Closet doors in the kitchen pantry were poorly installed and did not operate well. The Inspector recommends service by a qualified contractor.

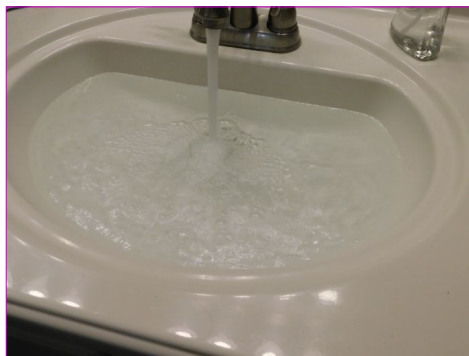
*MAIN FLOOR HALL BATHROOM Single Sink*

- At the time of the inspection, the Inspector observed no deficiencies in the condition of this bathroom sink.
- The bathroom sink had functional drainage at the time of the inspection.
- This bathroom sink had functional flow at the time of the inspection.
- This bathroom sink had functional flow and functional drainage at the time of the inspection.
- The sink installed in this bathroom had no overflow safety feature installed.

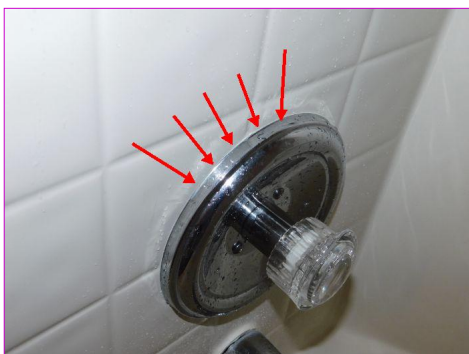
MAIN FLOOR HALL BATHROOM Bath Tubs

- The Inspector observed no deficiencies in the condition of bathtub components. Tub inspection includes testing for:
  - Functional flow;
  - Functional drainage; and
  - Operational shut-off valves, faucet, and diverter valve.
- The tub had functional flow.
- The tub was slow to drain. This is typically due to a clogged trap but may also indicate a blockage of the waste pipe. You may wish to have this condition investigated by a plumbing contractor.
- **No caulking noted around faucet handle. I recommend caulking be installed to prevent moisture intrusion into the wall.**
