# **Colliers Property Inspections** **Property Inspection Report**

5401 Test Drive Ave, Las Vegas, NV 89130  
Inspection prepared for: Justin Collier  
Date of Inspection: 2/19/2023 Time: 10:00 AM  
Age of Home: 22 Years Size: 2275  
Weather: Sunny and Clear

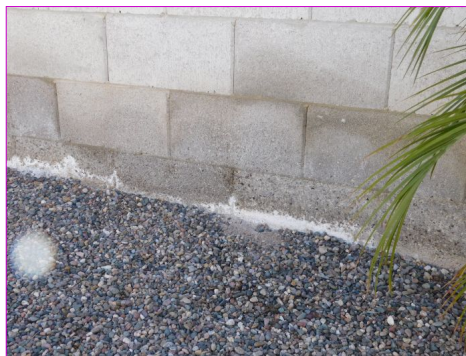
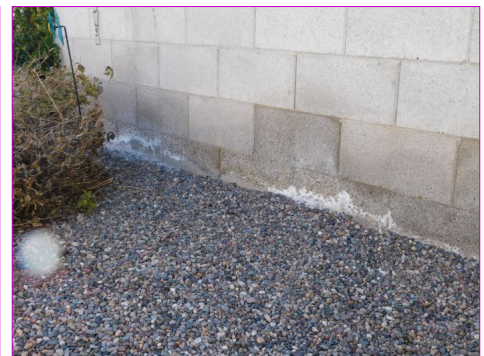
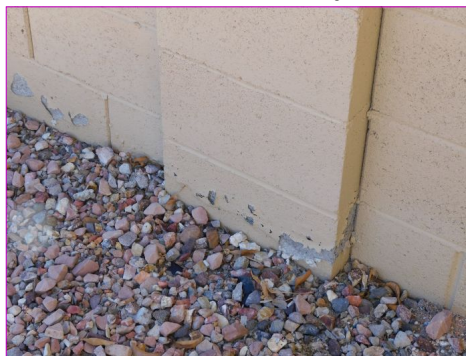
GROUNDS Boundary Walls

- Boundary walls were made of concrete masonry units (CMU) commonly called concrete block.
- Boundary walls exhibited moderate damage or deterioration. The inspector recommends repair by a qualified contractor.

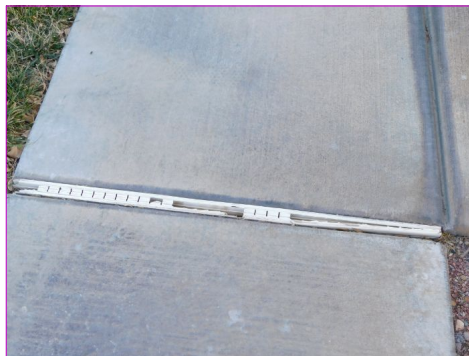
*GROUNDS Walkways*

- Home walkways were constructed of poured concrete.
- At the time of the inspection, the Inspector observed no deficiencies in the condition of the home walkways at the time of the inspection.
- Common cracks (1/4 inch or less) were visible in the sidewalk at the time of the inspection. Cracks exceeding 1/4 inch should be patched with an appropriate sealant to avoid continued damage to the walkway surface from freezing moisture.
- Walkway channel drain is damaged. I recommend repair or replacement by a licensed contractor.

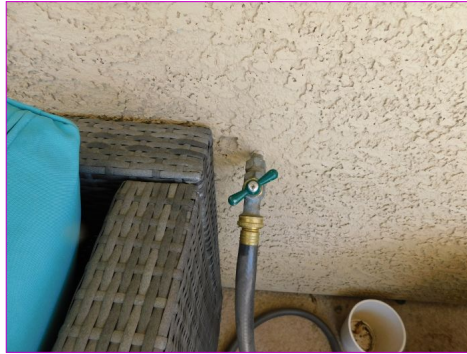
*EXTERIOR PLUMBING Exterior Faucets*

- At the time of the inspection, the Inspector observed no deficiencies in the condition of exterior water faucets.
- It is recommended to install an anti-siphon valve or device on the exterior hose bibs. This is especially important since this hose bib will likely be used to fill the pool. If a siphon event happens it could siphon pool water back up into the homes water system potentially contaminating drinking water.

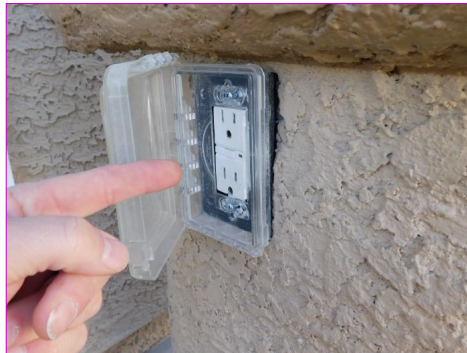
*EXTERIOR ELECTRICAL Exterior Electrical Receptacles*

- Most exterior electrical receptacles were Ground Fault Circuit Interrupter (**GFCI**)-protected and enclosed in weather-resistant covers. Exceptions will be listed in this report.
- The weatherproof cover for the front entry GFCI receptacle does not close completely. I recommend this be evaluated by a licensed electrician and repaired as needed.

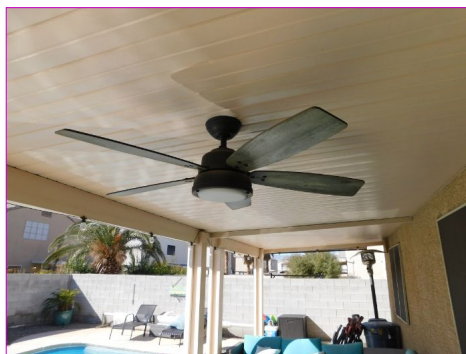
EXTERIOR ELECTRICAL Exterior Lighting

- There isn't a recommended height for ceiling fans in the National Electrical Code or International Residential Code, however most manufacturers recommend a height of no less than 7 feet from the ground. This fan is 81 inches from the ground and is 3 inches below most manufacturer recommendations. Recommend raising the fan if possible. However, a ceiling fan needs a minimum of 8 inches of clearance from the ceiling to produce it's full rated volume of air.
- Cover missing on light fixture. Recommend repair.

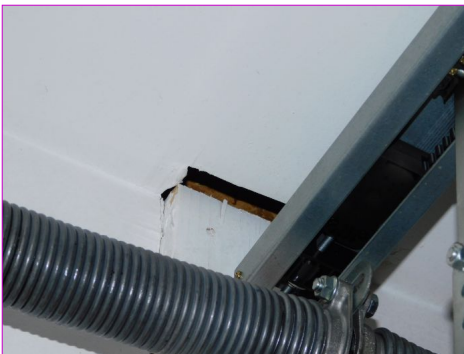
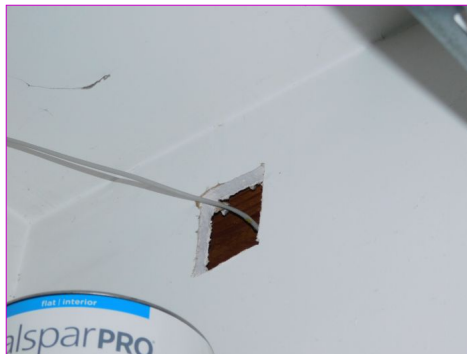
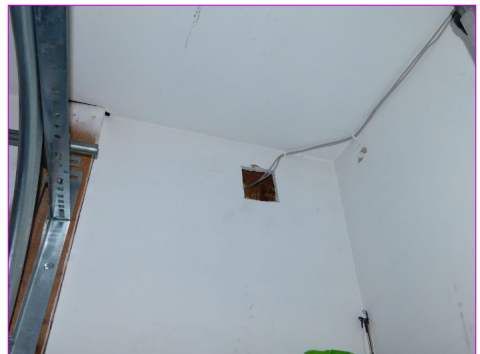
GARAGE Fire Separation

- The ceiling separating the garage from the home living space did not meet firewall safety requirements.

The Inspector recommends correction by a qualified contractor.

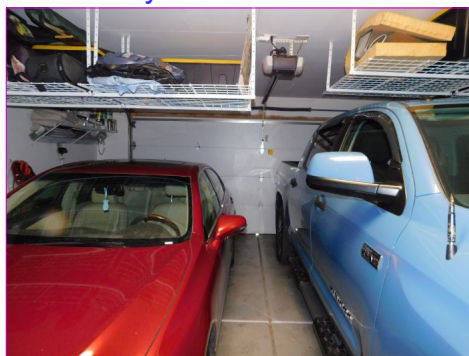
*GARAGE Garage Ceiling*

- At the time of the inspection, the Inspector observed no deficiencies in the condition of the garage ceilings.
- Overhead storage racks attached to the garage ceiling. I recommend these be reviewed and determine if they were installed to manufacturer recommendations.

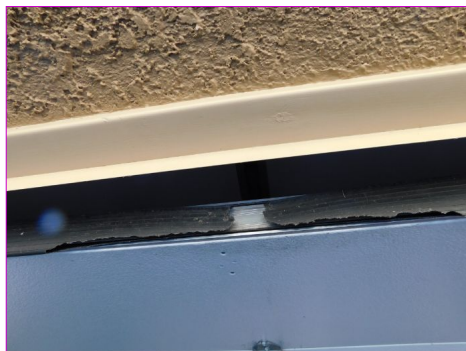
OVERHEAD GARAGE DOOR Door Panels

- The garage door sweep was damaged or missing. The sweep is the rubber gasket installed on the bottom of the door that seals the garage against air movement and pest entry.

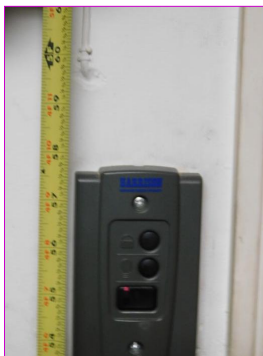
*OVERHEAD GARAGE DOOR Automatic Opener Switch*

- The garage door push-button switch was lower than the recommended 5-foot minimum height above the standing surface. This condition is potentially dangerous to children. The Inspector recommends that the switch be raised for safety reasons. All work should be performed by a qualified contractor.

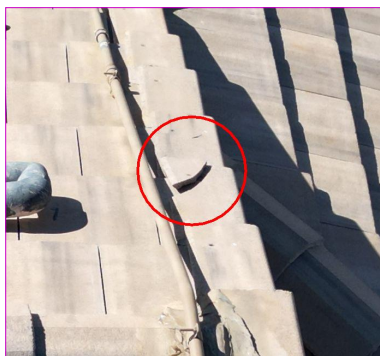
CONCRETE TILE ROOFS Tile  
Roof Condition

- The roof had cracked and/or broken concrete roof tiles that should be replaced to help prevent damage from moisture intrusion to the home materials, the roof structure and to prevent development of microbial growth such as mold. The Inspector recommends that before the expiration of your Inspection Objection Deadline you consult with a qualified contractor to discuss options and costs for repairs.

- Roof tiles that had been inadequately fastened have been displaced by wind. The tiles should be replaced by a qualified roofing contractor in a manner that will hold them securely in place.

- Concrete tiles in some portions of the roof were slipping downhill. These tiles had been cut to length, and fastener holes were discarded with tile waste. The Inspector recommends that any such tiles be replaced by a qualified roofing contractor using an appropriate adhesive.

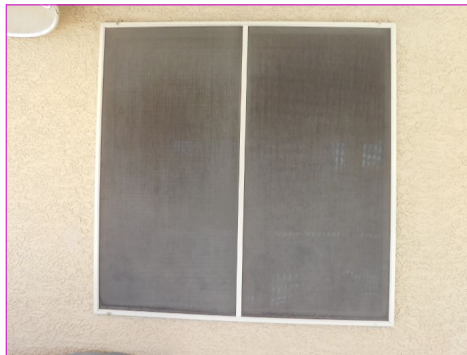
WINDOWS Window Type

- The outdoor inspection on the windows was limited due to the solar sun screens on the windows.

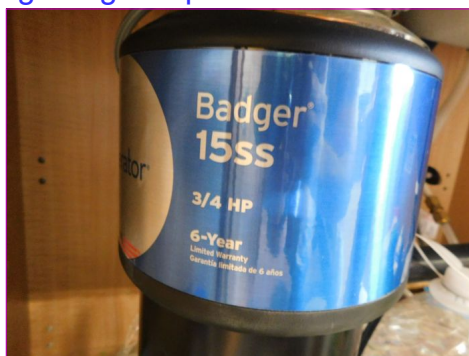
*KITCHEN Garbage Disposal*

- At the time of the inspection, the Inspector observed no deficiencies in the condition and operation of the garbage disposal.

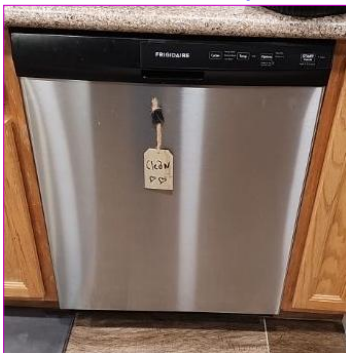
*KITCHEN Dishwasher*

- At the time of the inspection, the Inspector observed no deficiencies in the condition and operation of the dishwasher. It was operated through a cycle.

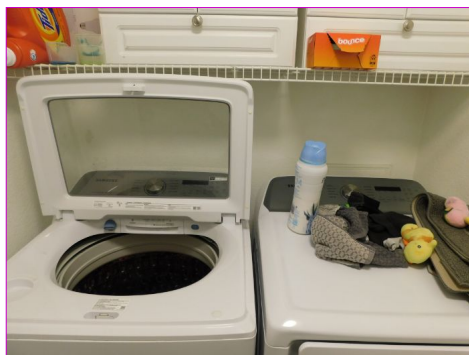
*LAUNDRY ROOM General Condition*

- At the time of the inspection, the Inspector observed no deficiencies in the condition of the laundry room.

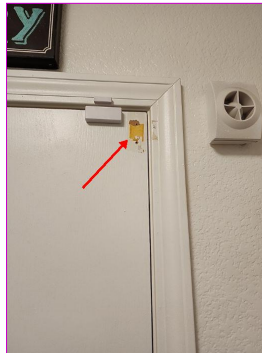
*LAUNDRY ROOM Exterior Door Condition*

- At the time of the inspection, the Inspector observed few deficiencies in the condition of the door to the exterior in the laundry room. Notable exceptions will be listed in this report.
- A door to the exterior in the laundry room exhibited light damage or deterioration at the time of the inspection.

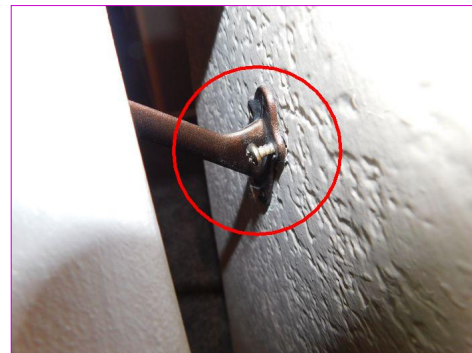
STAIRWAY to 2nd FLOOR Handrail Assembly

• The handrail at this staircase did not appear to have attachment hardware that adequately secured the handrail to the wall. Inspector recommends that attachment hardware be installed to make the handrail attachment to the wall secure. Physical testing for compliance with any building standards or building codes lies beyond the scope of the General Home Inspection. The Inspector recommends correction by a qualified contractor.

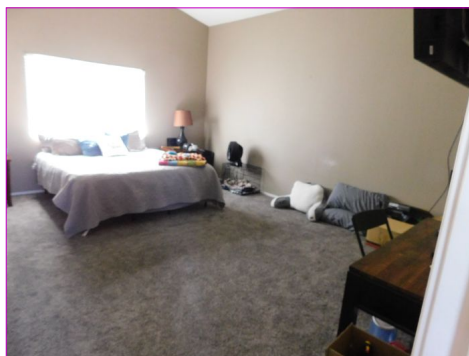
*MASTER BEDROOM General Condition*

- At the time of the inspection, the Inspector observed no deficiencies in the condition of floors in this bedroom.

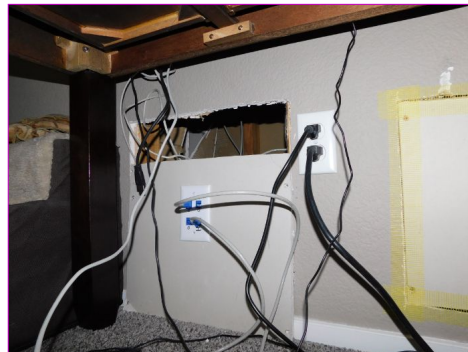
MASTER BEDROOM Walls

- The walls in this bedroom exhibited moderate damage. Before the expiration of your Inspection Objection Deadline you may wish to consult with a qualified contractor to discuss options and costs for repair.

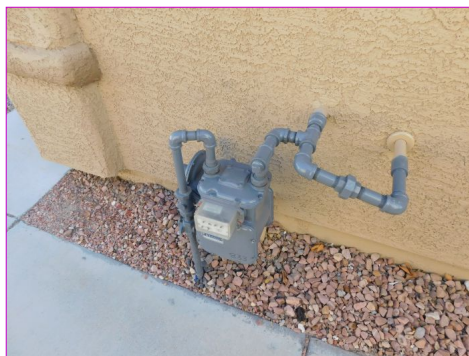
*GAS SYSTEM Main Gas Shut-off*

- The main gas shut-off was located at the gas meter located at the right side of the home.

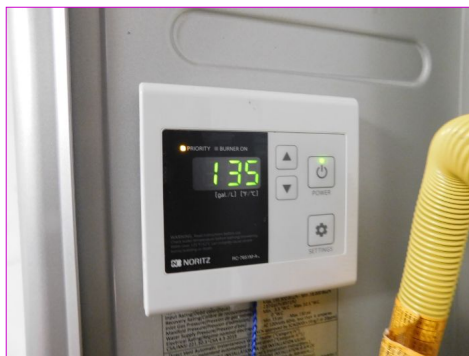
WATER HEATER INSPECTOR REFERENCE

- Water heater is set at 135

It is recommended to set the water temperature at 120 degrees or less to avoid scalding. Children and the elderly more susceptible to scalding themselves when using the hot water.

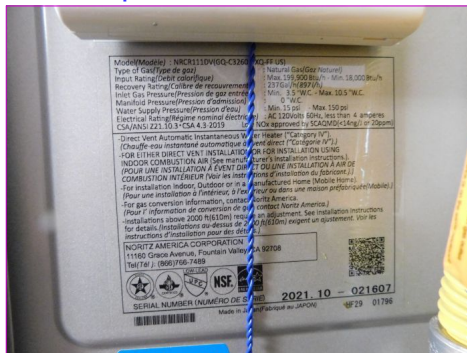
WATER HEATER Water Heater Data Plate Information

- The photo shows the data plate of the water heater.

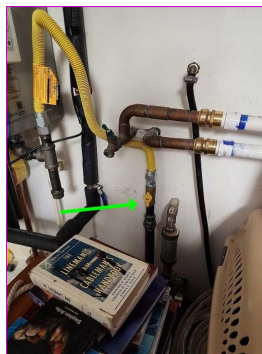
WATER HEATER Fuel Supply

- This gas-fired water heater was equipped to burn natural gas.
- The photo shows the location of the shut-off valve for gas at the water heater.

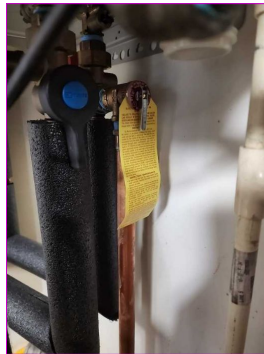
WATER HEATER Pressure Relief Valve

- At the time of the inspection, the Inspector observed no deficiencies in the condition of the temperature/pressure relief (TPR) valve (not tested).

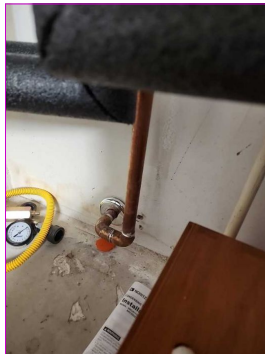
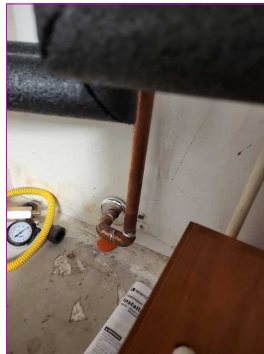
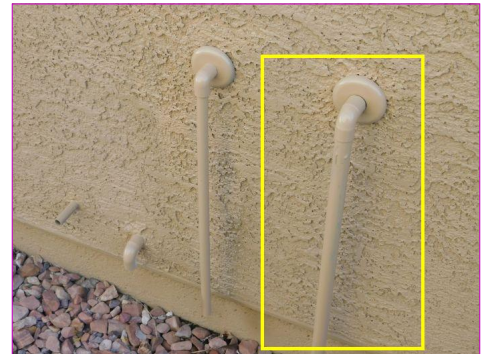
WATER HEATER TPR Discharge Pipe

- At the time of the inspection, the Inspector observed no deficiencies in the condition of the TPR discharge pipe.

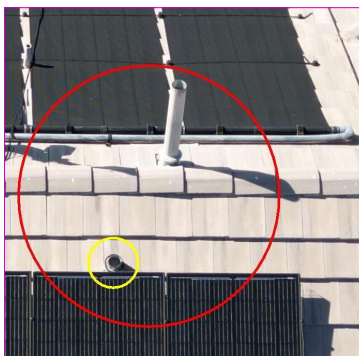
*FURNACE Combustion Exhaust Venting*

- At the time of the inspection, the Inspector observed no deficiencies in the condition of the combustion exhaust vent of the furnace.

- Rain cap missing from furnace exhaust vent. Cap appears to be sitting on the roof lying above the solar panel array. Recommend having a licensed HVAC tech install a new rain cap to keep water from enter the furnace.

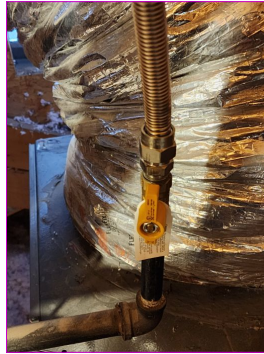
*FURNACE Furnace Shut-offs*

- The furnace gas shut-off is shown in the photo.

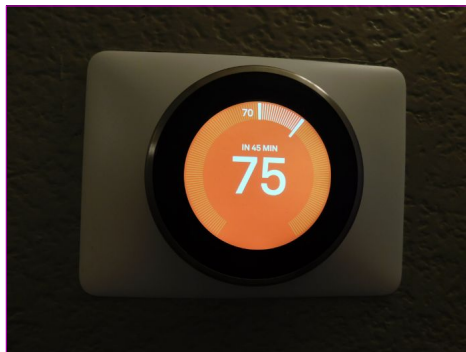
*FURNACE Thermostat*

- The thermostat for this furnace was located in the upstairs hallway.

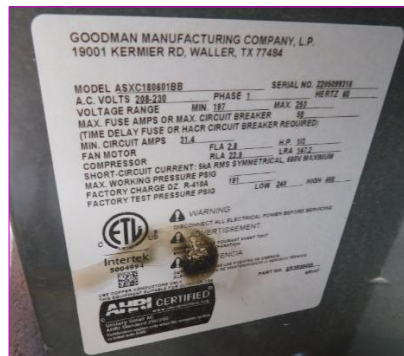
CENTRAL AIR CONDITIONER Cooling System Data Plate

- Information from the air-conditioner label/data plate is shown in the photo.
- The air-conditioner date of manufacture appeared to be 2022.

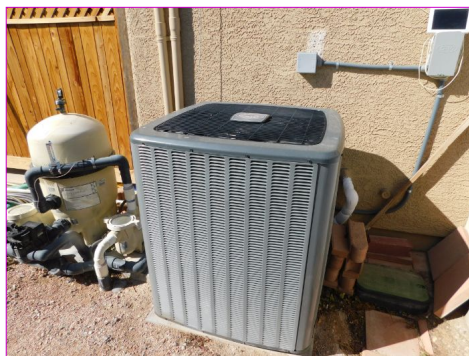
*CENTRAL AIR CONDITIONER General Condition*

• The inspection was limited due to outdoor temperature. The air conditioning system was not operated because of the outdoor ambient temperature was below 60 degrees at the time of inspection.

• At the time of the inspection, the Inspector observed no deficiencies in the condition of the air-conditioning system.

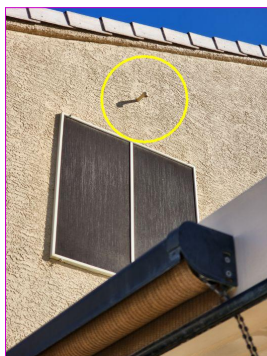
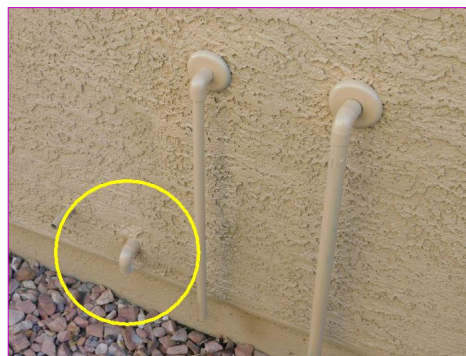
CENTRAL AIR CONDITIONER Condensate Disposal

• Secondary condensate disposal is located above 3rd upstairs bedroom window. This condensate line is a back up line in case the primary condensate line become blocked or plugged up. If you see condensate discharging from this pipe it is recommended you call a licensed HVAC contractor to evaluate the problem.

• Primary condensate disposal is located on the right side of the home down low near the walkway.

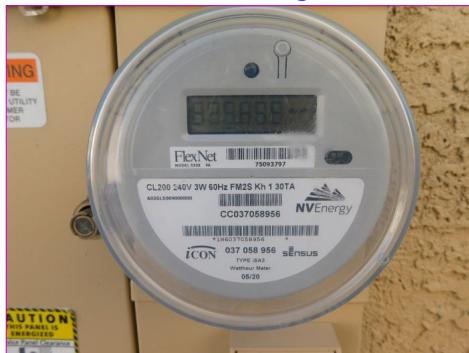
*ELECTRICAL SERVICE Electric Meter Location*

- The electric meter was located at the right side of the home.

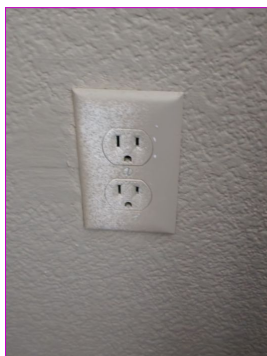
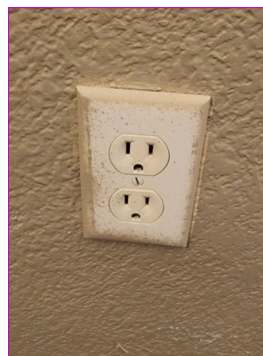
*BRANCH WIRING Receptacle Deficiencies*

- Electrical receptacles in the home had been painted, making insertion of a plug difficult. Some receptacles will need to be replaced for this reason. All electrical work should be performed by a qualified electrical contractor.

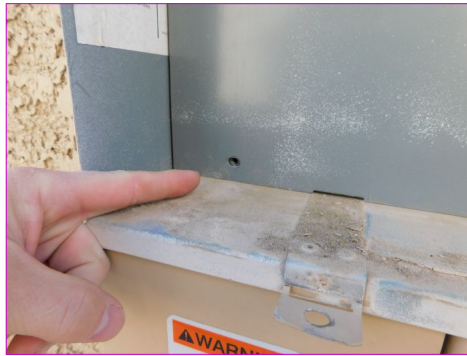
*SERVICE PANEL Dead Front Cover Condition*

- The dead front cover of the electrical service panel was missing screws. The Inspector recommends that appropriate screws be installed to securely attach the dead front cover.

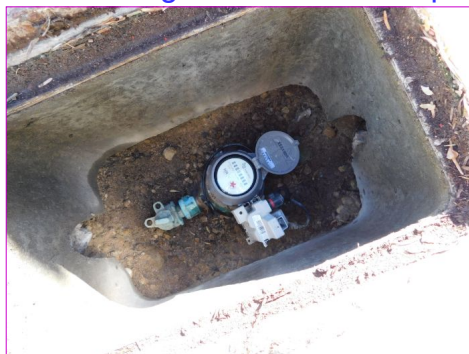
WATER SUPPLY SOURCE Water Supply

- The home water was supplied from a public source.
- Water meter is located in the ground at the front public sidewalk.

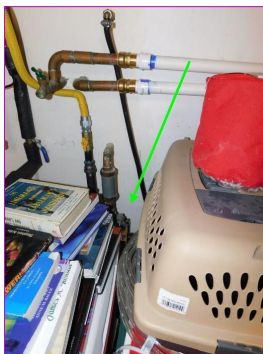
WATER SUPPLY PIPES Main Water Shut-off

- The main water supply shut-off was located .
- The main water supply shut-off valve was difficult to access because of occupant belongings piled up in front of the shut off valve.

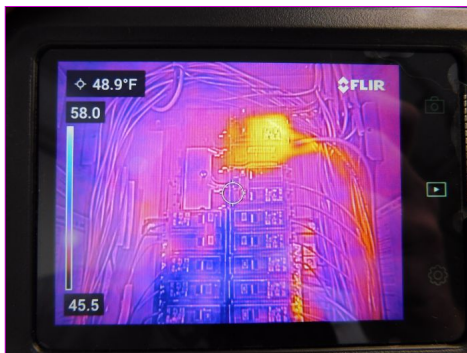
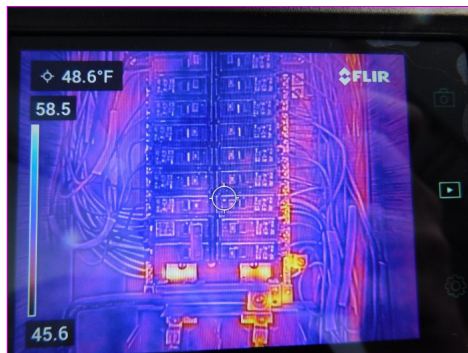
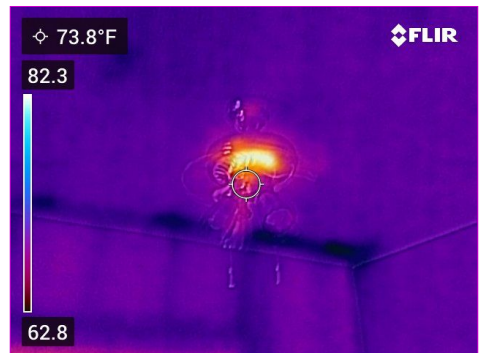
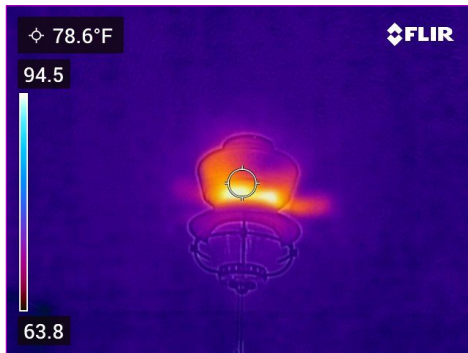
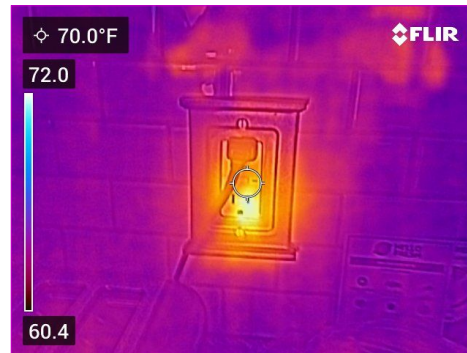
THERMAL IMAGING Electrical

- No out of range temperatures were found within the homes electrical system.

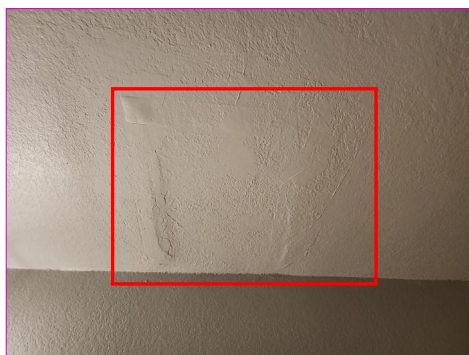
MAIN FLOOR HALL BATHROOM Ceiling

- At the time of the inspection, the Inspector observed few deficiencies in the condition of this bathroom ceiling. Any exceptions will be listed in this report.
- Ceilings in this bathroom exhibited evidence of poor drywall installation.
- Patching of the ceiling in this bathroom was poorly executed.

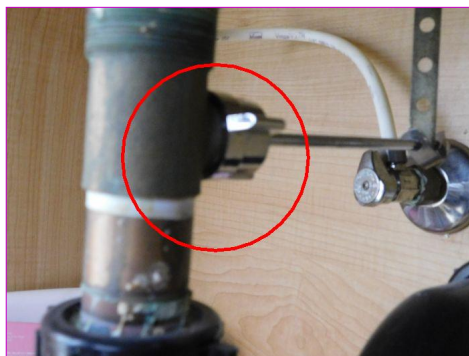
UPSTAIRS HALL BATHROOM Undersink Plumbing

- Sink pop up drain leaking at drain pipe. Recommend a licensed plumber repair or replace to avoid further leaks.

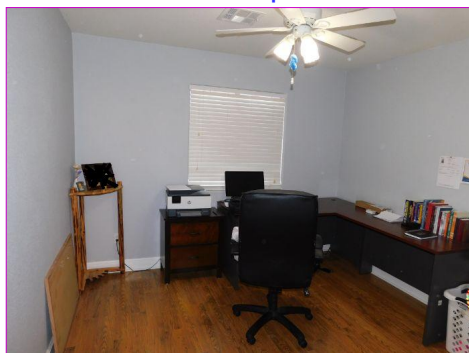
*1st UPSTAIRS BEDROOM General Condition*

- At the time of the inspection, the Inspector observed few deficiencies in the condition of floors in this bedroom. Notable exceptions will be listed in this report.

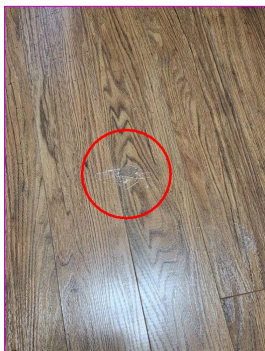
1st UPSTAIRS BEDROOM Wood Floors

- Laminate wood flooring.
- Damaged section of the laminate flooring. Repair or replace as needed.

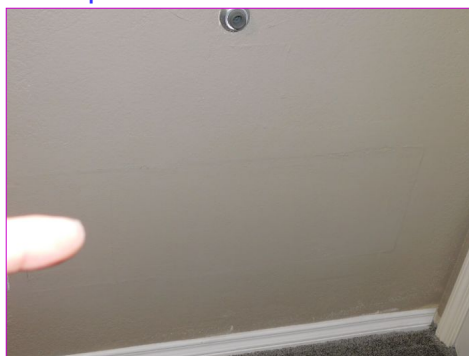
*2nd UPSTAIRS BEDROOM Walls*

- At the time of the inspection, the Inspector observed few deficiencies in the condition of. Notable exceptions will be listed in this report.
- Notable drywall patch/repair work done behind door. Poor quality repair work.

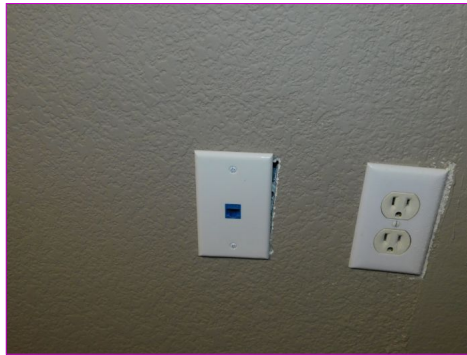
*2nd UPSTAIRS BEDROOM Electrical Receptacles*

- Ethernet outlet wall plate does not fully cover box cutout.

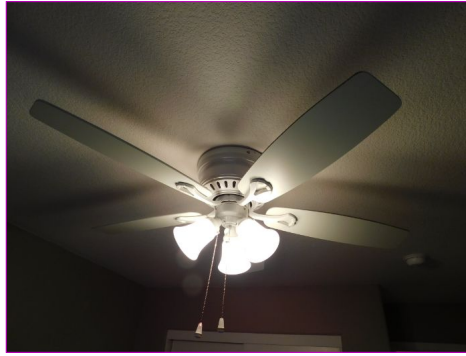
3rd UPSTAIRS BEDROOM Ceiling Fan

- A ceiling fan in this bedroom was inoperable. The Inspector recommends an evaluation and any necessary work be performed by a qualified electrical contractor.

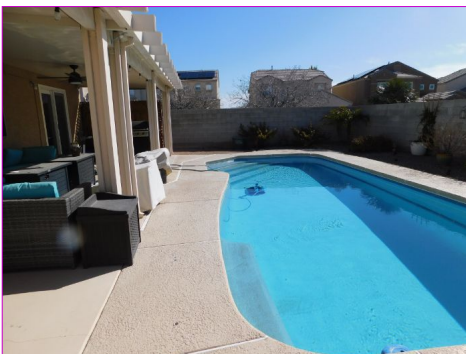
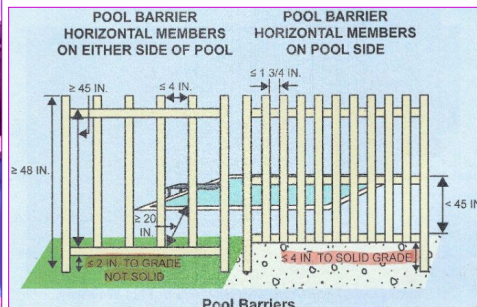
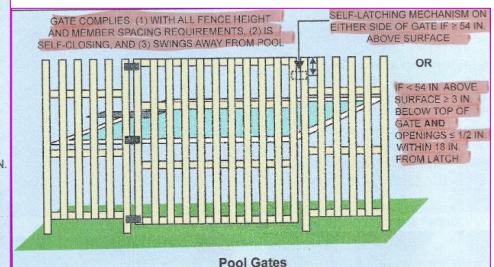
SAFETY HAZARDS Pool Barriers

House walls with openings that provide access to the pool or spa and are part of the pool or spa access barrier system should be equipped with some mechanism that either restricts unauthorized access to the pool or sounds an alarm if access is attempted. This includes openings such as the garage service door. A door should be self-closing and self-latching. The door lock should be at least 54 inches above the floor and the door swing into the house. Window latches should be at least 54 inches above the floor or the opening size be limited to 4 inches or less. An approved alarm may be substituted in place of the door and window requirements.

Openings such as pet doors should not provide access to the pool area. Children can crawl through these openings.
